INJURED AND DEAD FISH IN THE VICINITY OF BONNEVILLE DAM

SPECIAL SCIENTIFIC REPORT: FISHERIES No. 29

**UNITED STATES DEPARTMENT OF THE INTERIOR
FISH AND WILDLIFE SERVICE**

Special Scientific Report - Fisheries
No. 29

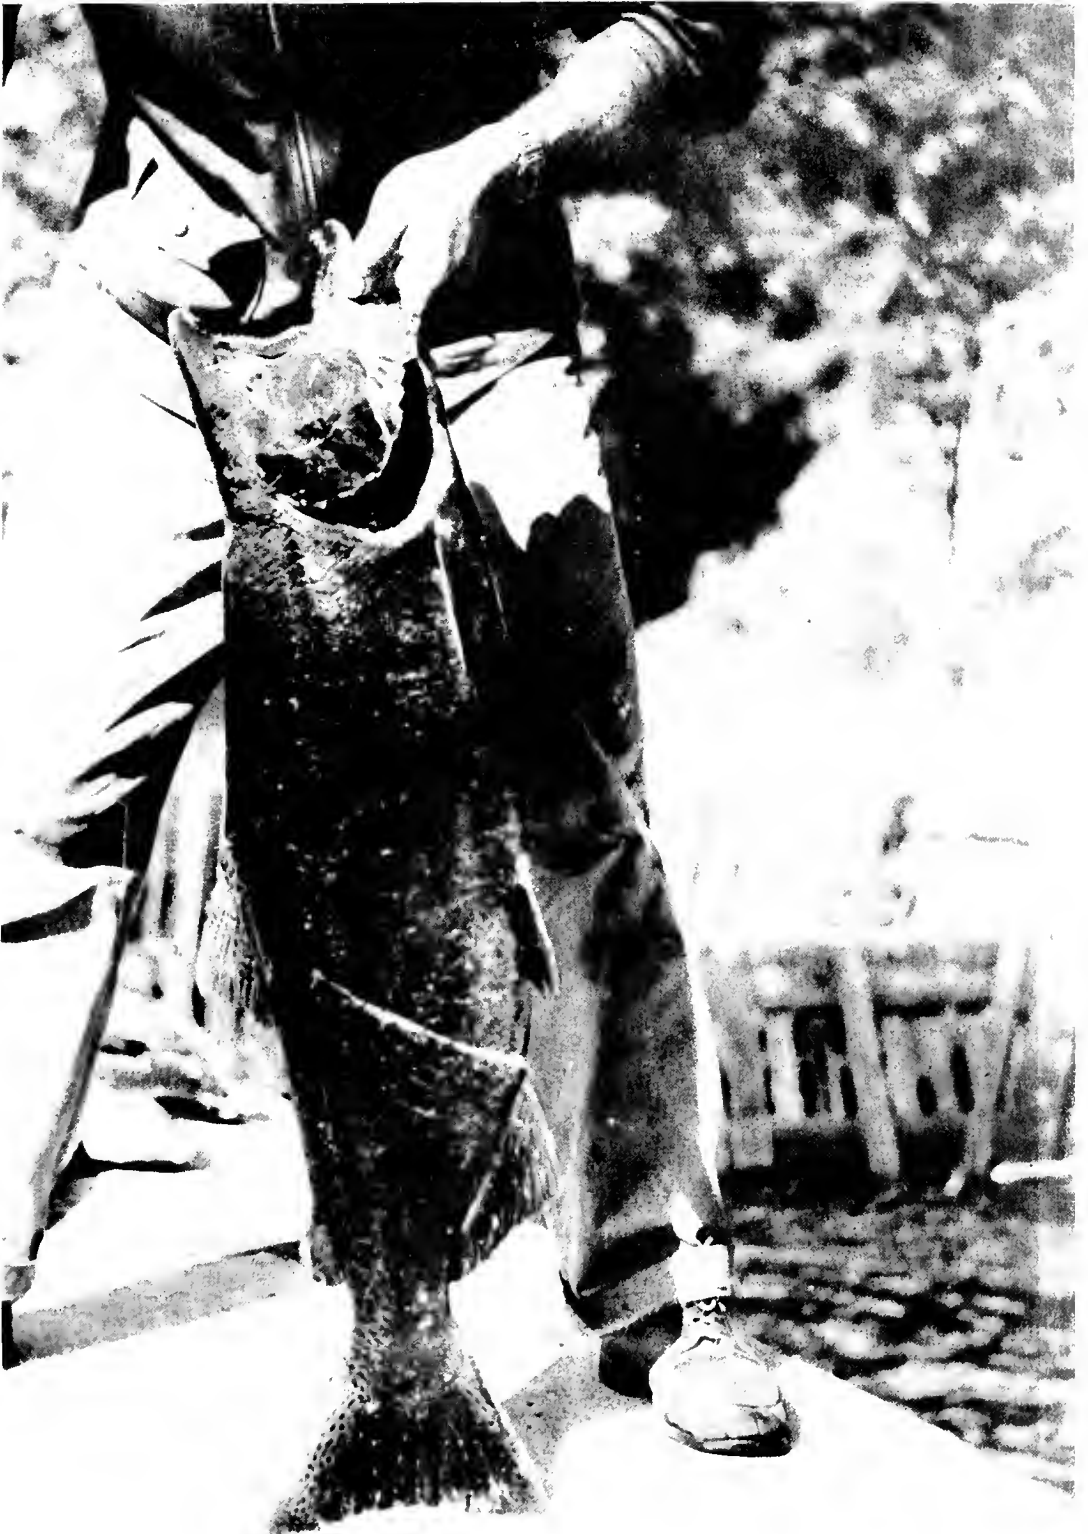
Figure 1.-- Chinook Salmon with dorsal and ventral fin injuries observed at Big White Salmon Hatchery.

Of the 499 fish with dorsal-fin injuries, 78.9 percent had the accompanying ventral-fin injuries. All of the fish with encircling abrasions had both dorsal and ventral cuts. It is apparent in Figures 1 and 2 that these injuries were caused by nets.

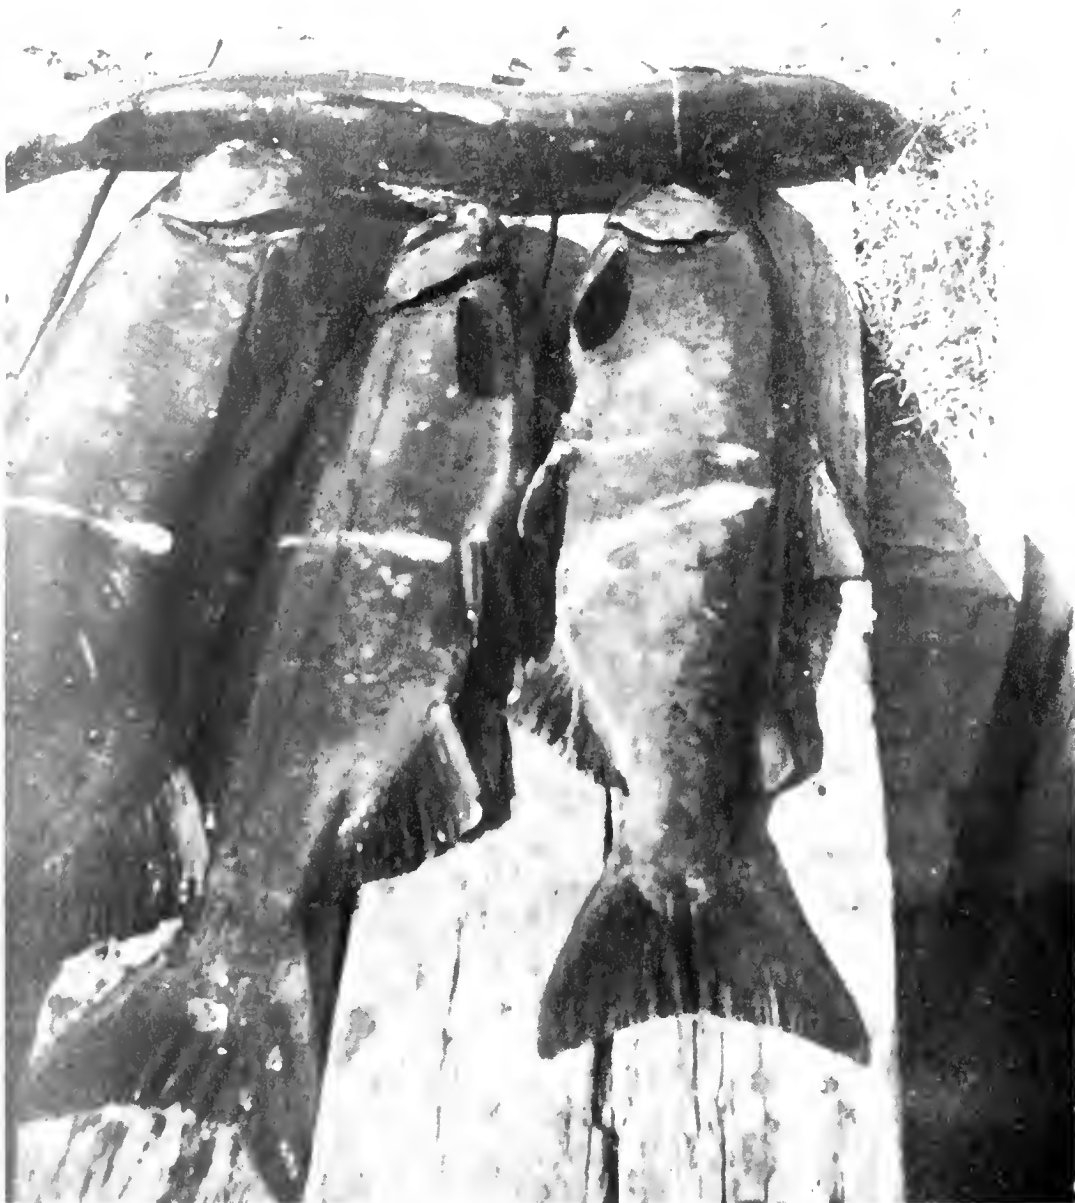
Figure 2.--Chinook Salmon with dorsal and ventral fin injuries plus the completely encircling abrasions observed at Big White Salmon Hatchery.

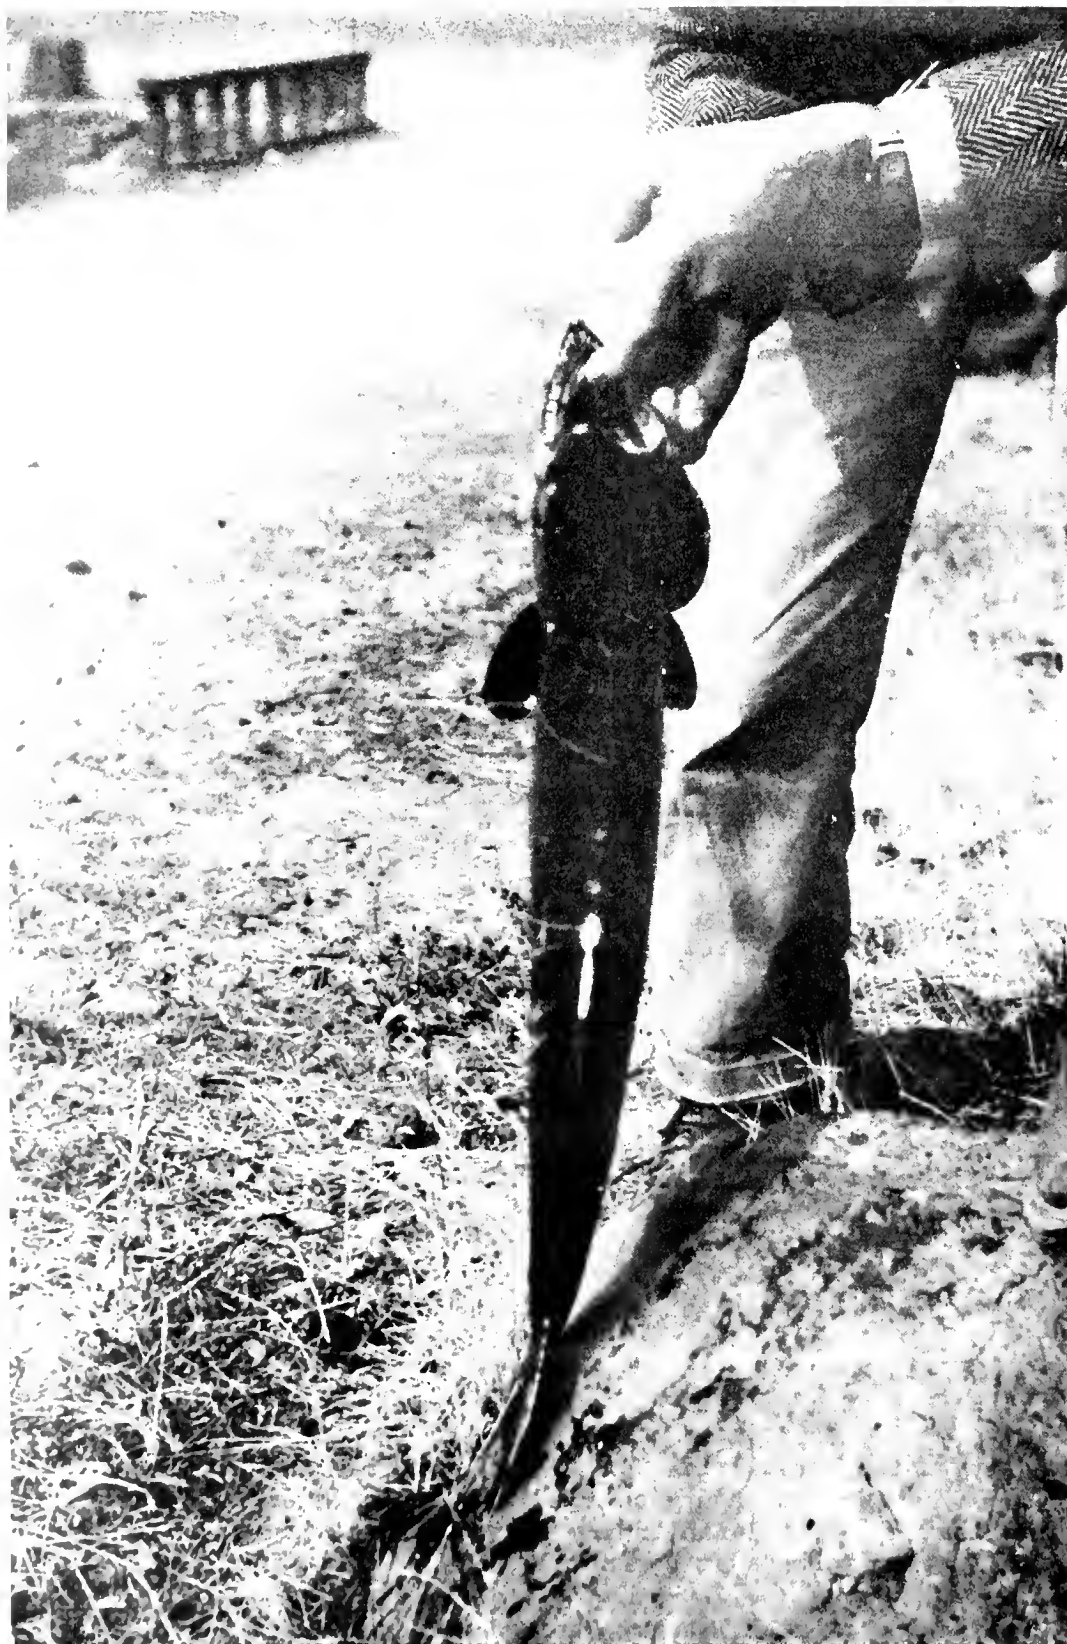
Figure 3.--Chinook Salmon with dorsal fin injuries
observed at Bonneville Hatchery.

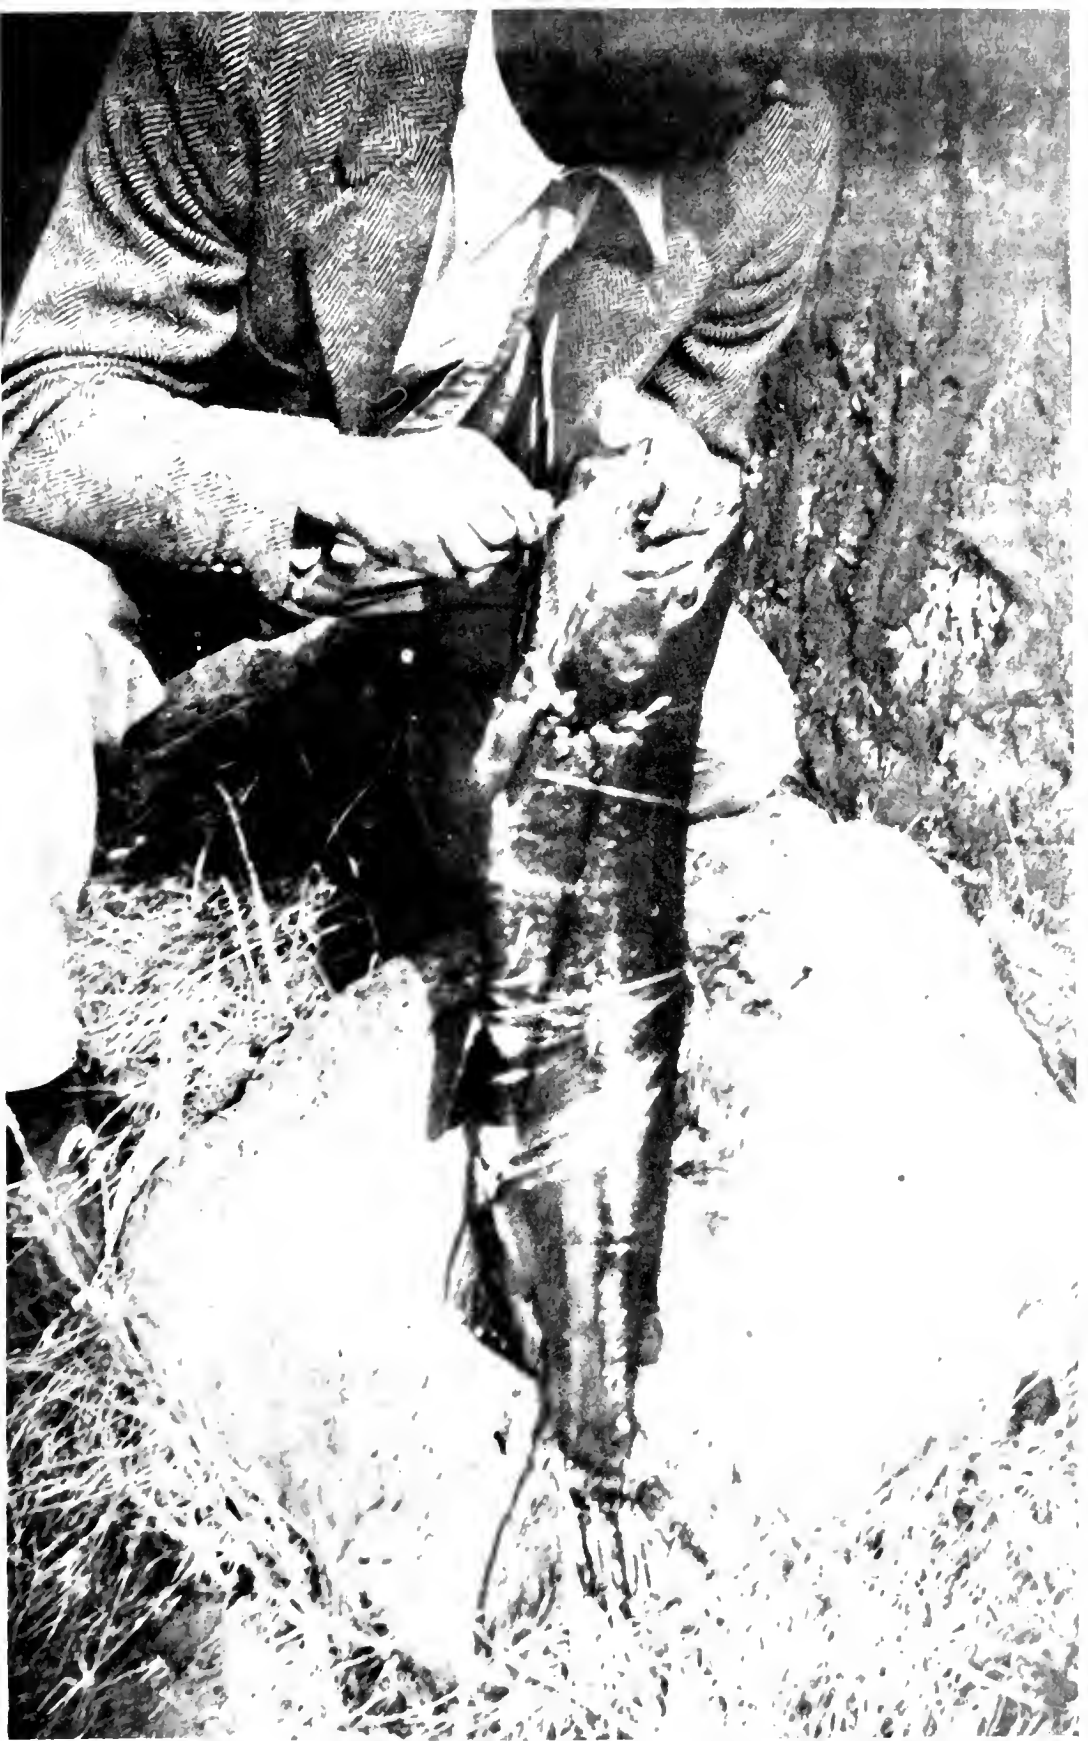
Figure 4.--Chinook Salmon with ventral fin injuries and completely encircling abrasions observed at Bonneville Hatchery.

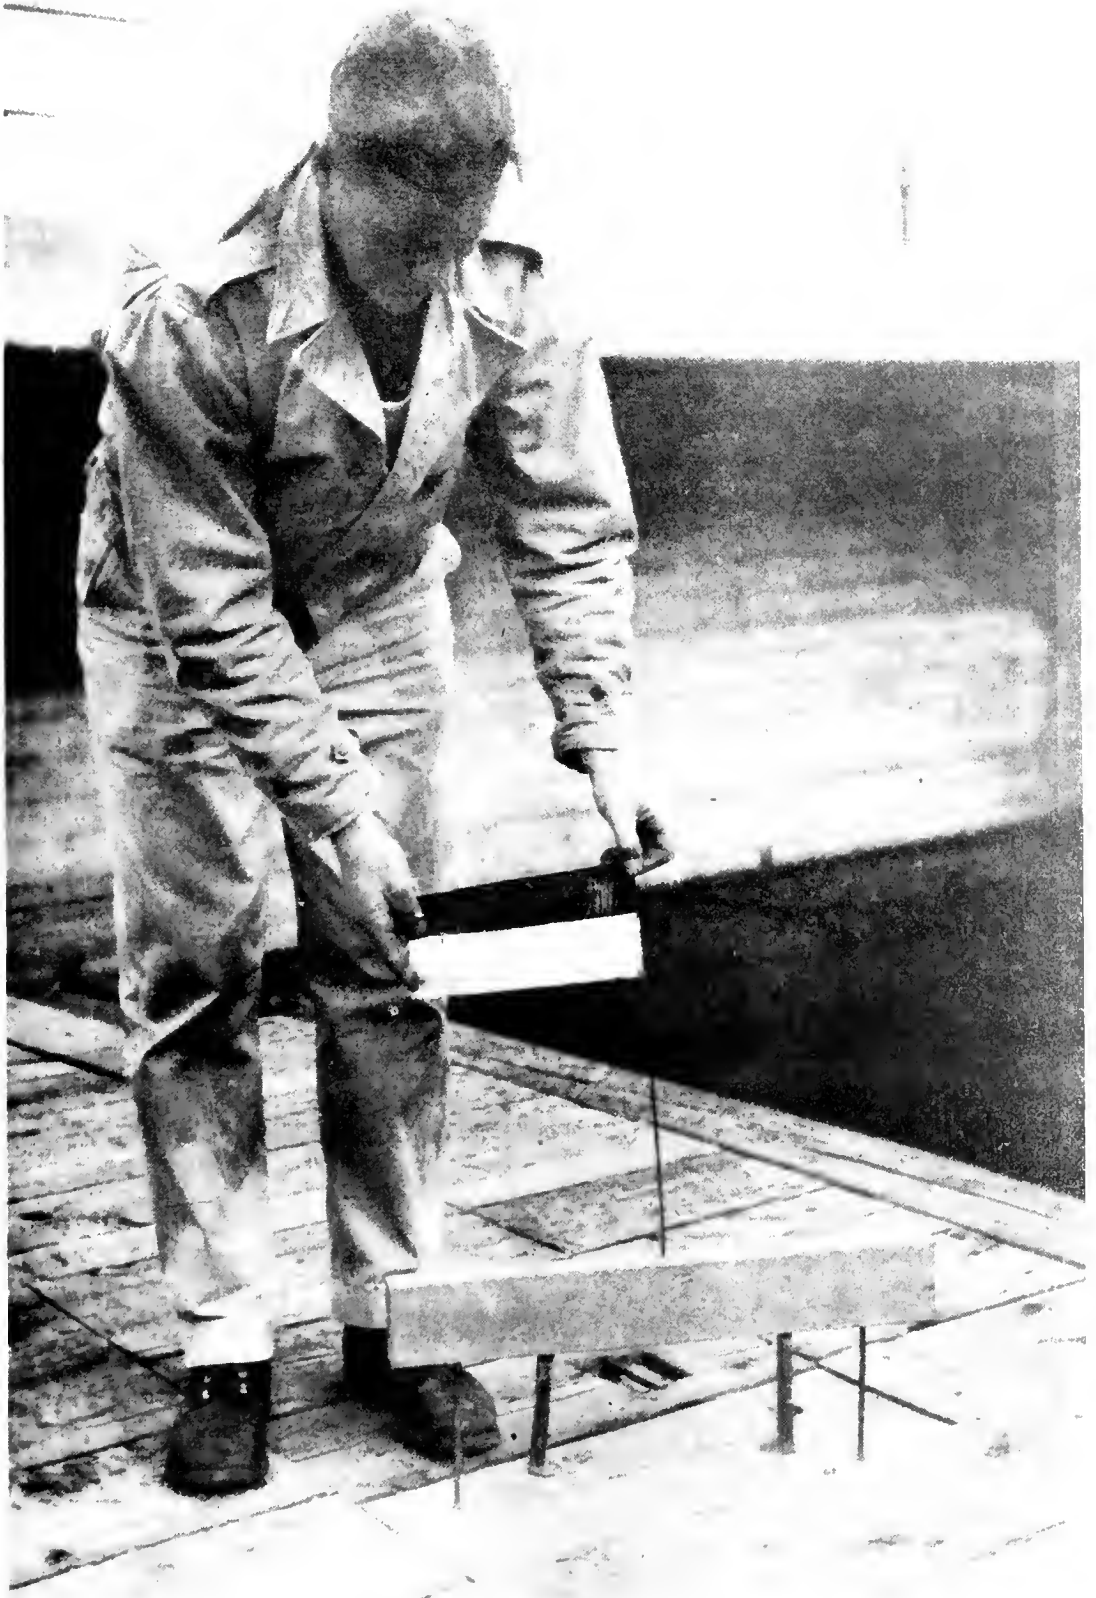
Figure 6.--Wooden float used in experiment to determine direction and influence of wind drift below Bonneville Dam.

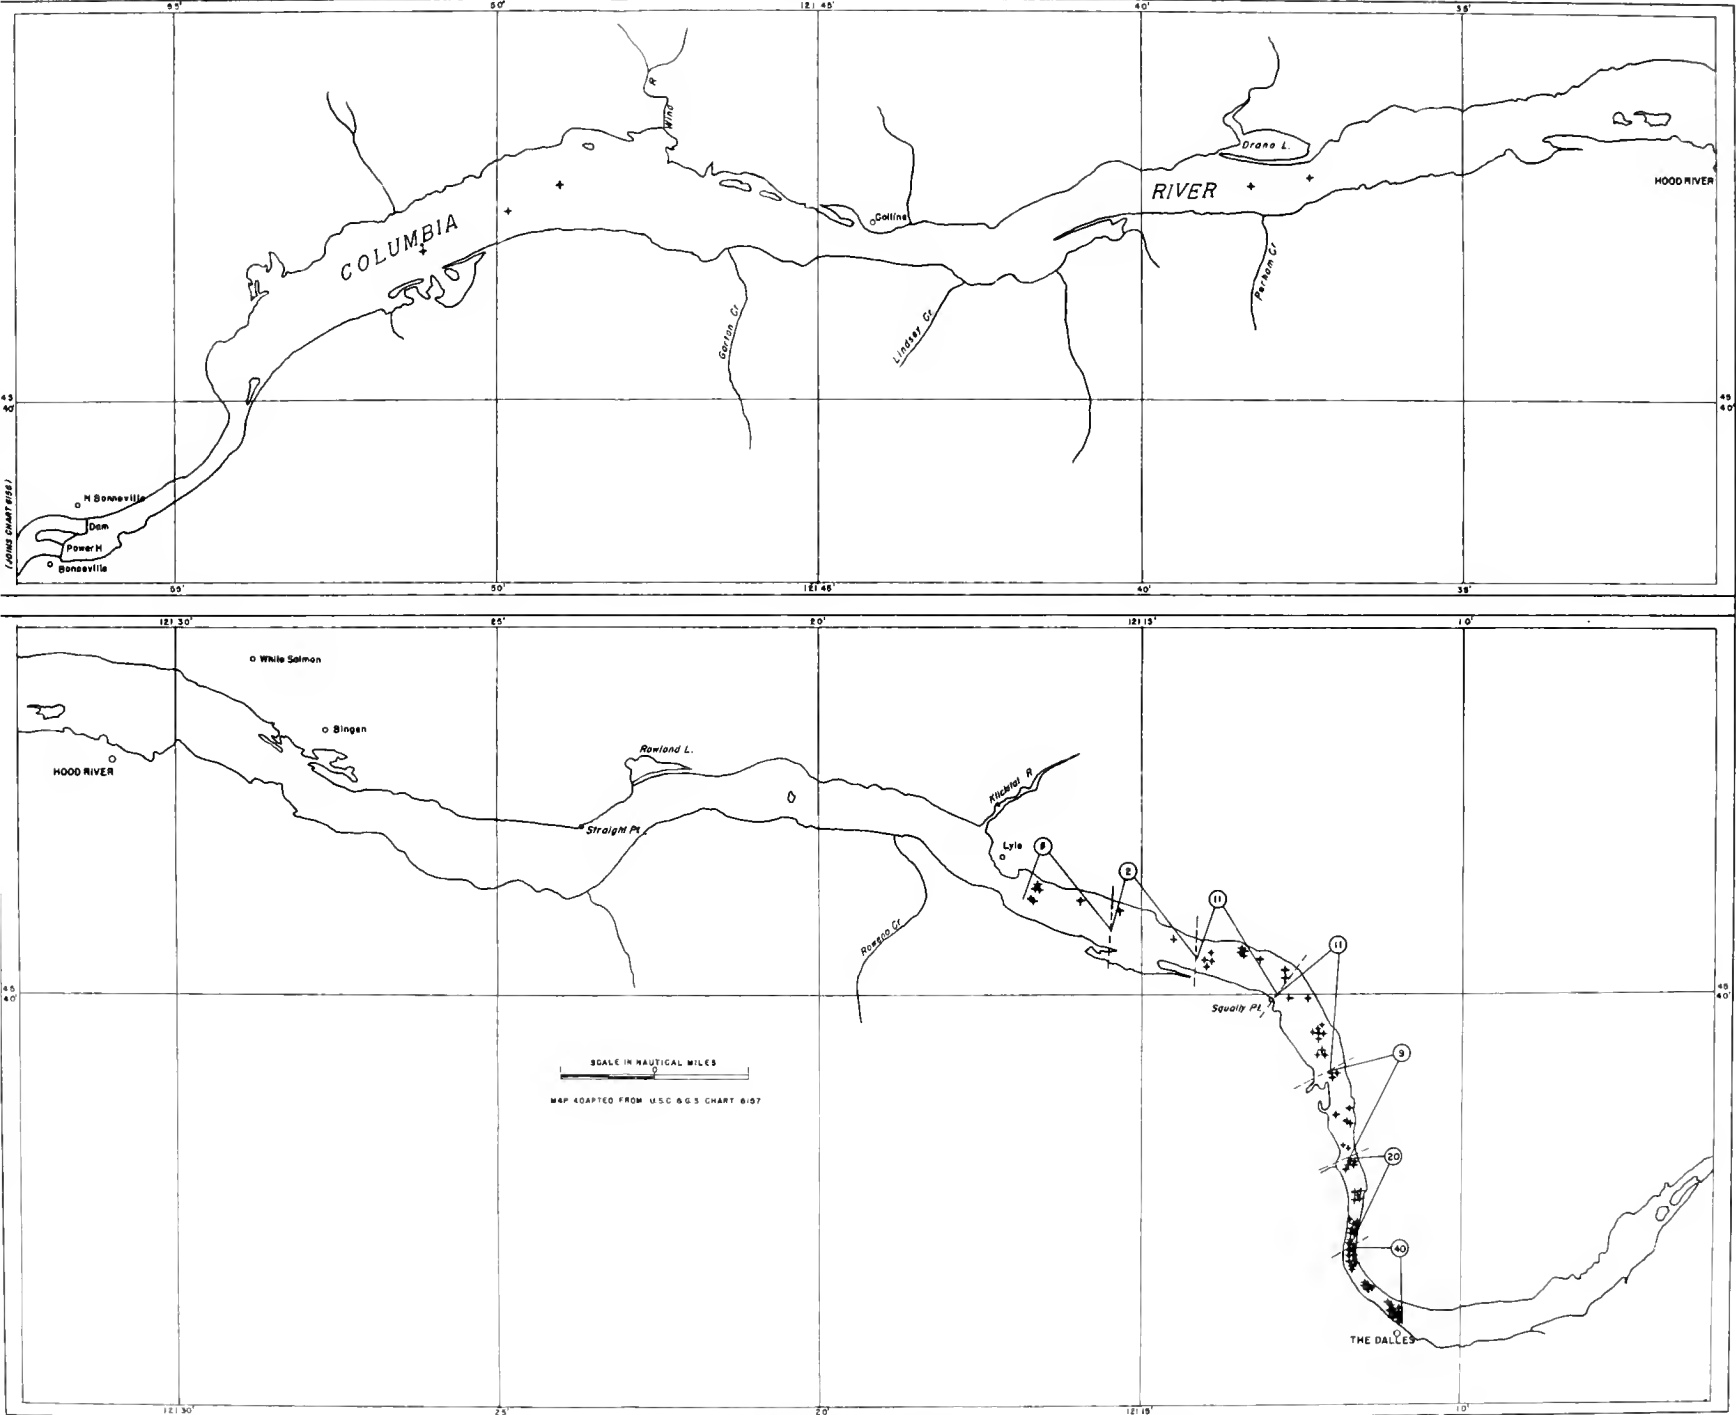
Figure 9.-- Approximate location and number of dead fish found between Bonneville Dam and The Dalles, Washington, 1946.

U. S. Coast and Geodetic Survey charts for the Columbia River from Vancouver, Washington, to The Dalles, Oregon have been reproduced in Figures 8 and 9, and have been marked off in 1-mile sections from The Dalles, Oregon, to Lyle, Washington, and from Bonneville Dam to Cape Horn, Washington. The numerals in the circles refer to the numbers of dead fish found in each 1-mile section. Only fish found in 1946 during the period of the fall run are included in the figures encircled. Figure 8 also includes 21 dead salmon and steelhead trout which were picked up just below the spillway section on September 6 and October 3, 1946.
